## Exhibit E

Re: Brico Industries' InnerSeal II Submittal Information  
 WASM 1 & 2, MWRA Contract #6280

**SUBJECT:** WASM 1 & 2 - MWRA Contract #6280,  
InnerSeal II Testing Requirements

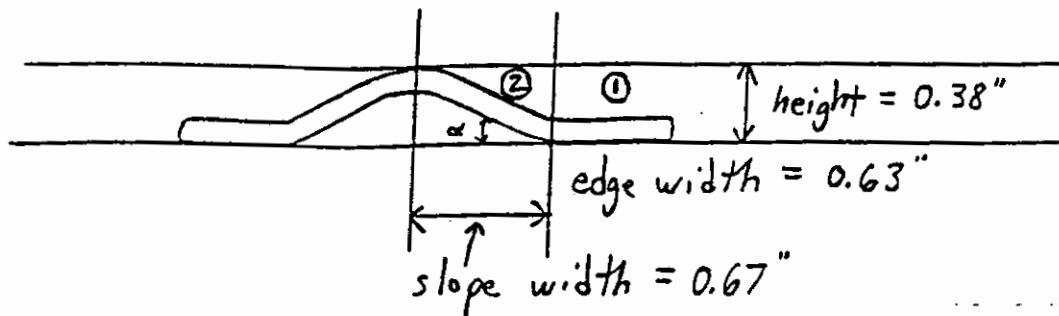
2. Find  $I$  of Inner Seal II band,  $0.105"(12 \text{ ga.}) \times 2.60"$

Area ① is a rectangle  $\therefore A_1 = 0.105 \times 0.63 = 0.0662 \text{ in.}^2$

Area ② is a rectangle  $\therefore \alpha = \tan^{-1}\left(\frac{0.3275}{0.67}\right) = 26^\circ$

$0.0025 \gg 0.0011$   $\therefore$  band design is satisfactory
